NATIONAL PROGRAM FOR INSPECTION OF NON-FEDERAL DAMS  
MURPHY DAM (NH 00185)...(U) CORPS OF ENGINEERS WALTHAM  
MA NEW ENGLAND DIV AUG 81

REPORT DOCUMENTATION PAGE		READ INSTRUCTIONS BEFORE COMPLETING PAGE
1. REPORT NUMBER NH 00185	2. GOVT ACCESSION NO.	3. RECIPIENT'S CATALOG NUMBER
4. TITLE (and Subtitle) Murphy Dam NATIONAL PROGRAM FOR INSPECTION OF NON-FEDERAL DAMS		5. TYPE OF REPORT & PERIOD COVERED INSPECTION REPORT

DAM: Murphy  
IDENTIFICATION NO. N.H. 00185

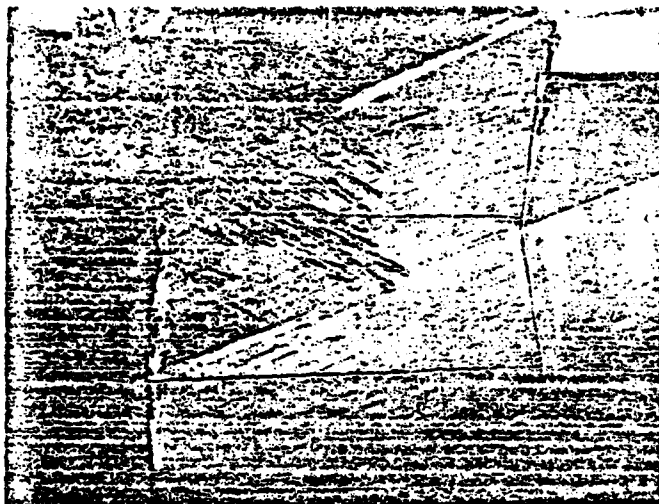
1. Reinforced concrete is exposed in at least one spot on bridge roadway. Suggest asphalt paving of roadway to seal concrete.
2. Minor spalling of concrete joints downstream with abutment as shown in attached photo. (see next page.)

Highway Bridge to control house over spillway outlet channel. Shows downstream north abutment spalling.

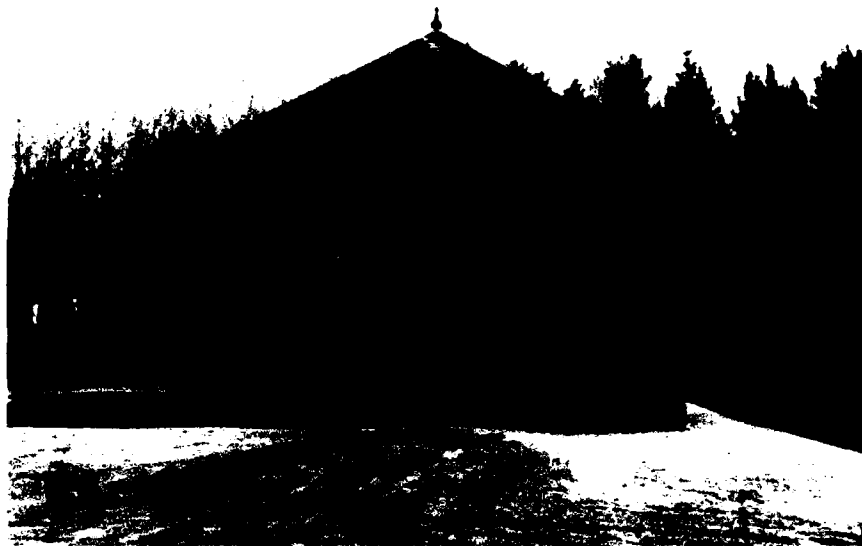
The control house located downstream of the dam was in good condition, Photo No. 11. The two electric motor operated 84-in. Dow butterfly valves were opened to drain the outlet conduit and permit its inspection, Photo No. 14. The low flow 30-in. Dow valve was operated manually. An emergency stand-by gasoline engine is available for operation of the 84-in. Dow valves. During the control house inspection, this engine was started and kept running for a time, demonstrating its operable condition.

11. Control house

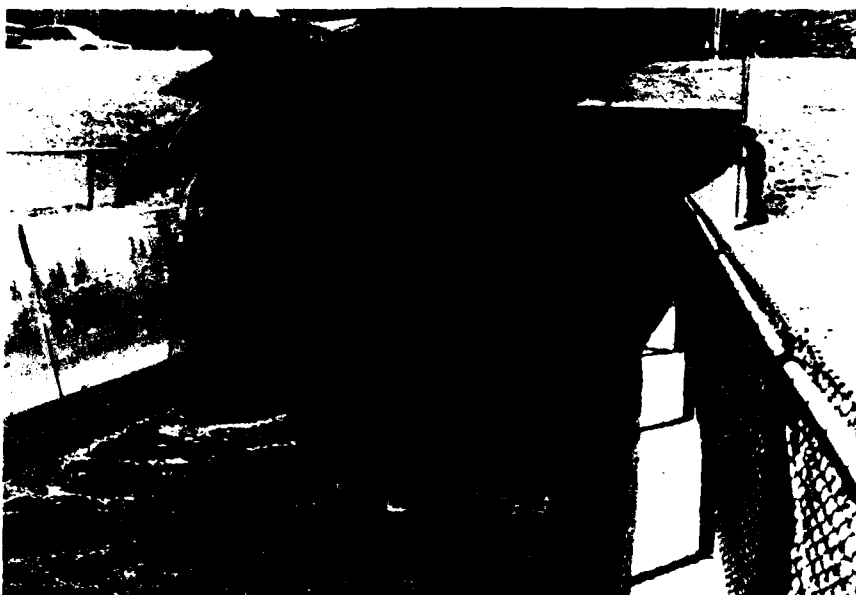
13. Stilling pool being drained
